**CONDOR EARTH TECHNOLOGIES, INC.**

October 9, 2014

**Subject:** Summary and Recommendations – El Portal Fire Sediment/Debris Runoff Mitigation,  
Title I Services Scoping Trip, Old El Portal, California, Yosemite National Park  
Condor Project No. 6945

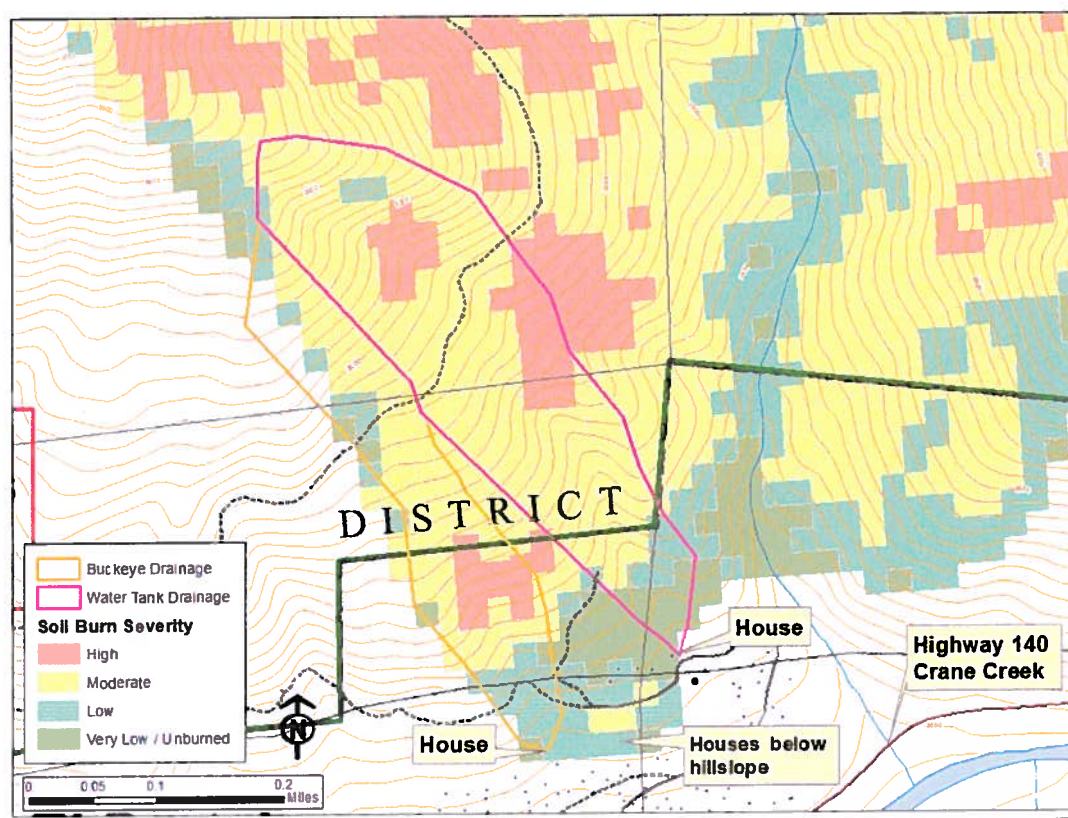
Figure 1: Map of fire area showing the houses in drainages and Crane Creek bridge at Highway 140

**House in drainage near water tank-** There is a house located directly within the mouth of a 33 acre ephemeral drainage (Figures 1 and 2). The drainage is narrow, steep (average slope-63%), and very rocky with rock outcrops at its head. The entire watershed was burned, with soil burn severity dominated by *Moderate* (Table 2). This house previously experienced flooding and fine sediment deposition during a storm event in March 1991 that occurred after the watershed was burned during the August 1990 Arch Rock Fire (DeGraff 1991). A rock gabion dam debris basin with an approximately 200 cubic yard capacity was constructed in the channel upstream from the house near the upper water tank after the Arch Rock Fire to provide protection from debris flows; the March 1991 event filled the structure about half full with fine sediment and ash (DeGraff 1991).

**House in drainage on Buckeye Road-** This house is located directly within the mouth of an 18 acre ephemeral drainage and was identified during field reconnaissance (Figures 1 and 3). This drainage is also narrow, steep (average slope- 55%), and rocky with rock outcrops at its head. Nearly all the watershed (91%) was burned, mostly at a *Moderate* soil burn severity (Table 2). The drainage becomes indistinct at the house and it appears no other homes are at risk. The house experienced a small debris flow during the March 1991 storm event which deposited 1 foot of debris against the back of the house (DeGraff 1991). Several unsuccessful attempts were made to contact the homeowner. Where Foresta Road crosses the drainage upstream from the house, there is potential for runoff to divert onto the road and flow down to water tank.
